**NASA TECHNICAL
MEMORANDUM**

NASA TM X-64566

**INVESTIGATION OF FATIGUE PROBLEM IN 1-MIL
DIAMETER THERMOCOMPRESSION AND ULTRASONIC
BONDING OF ALUMINUM WIRE**

November 30, 1970

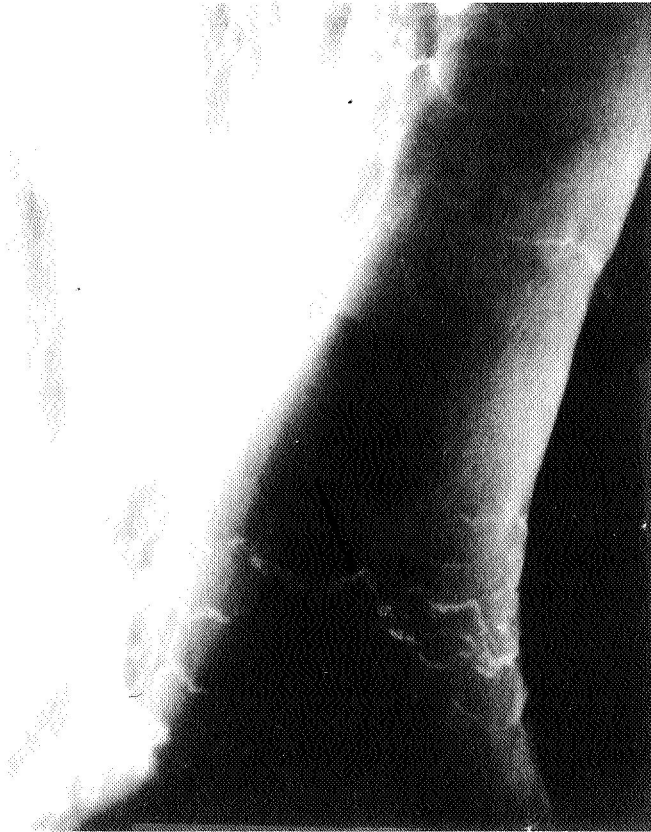
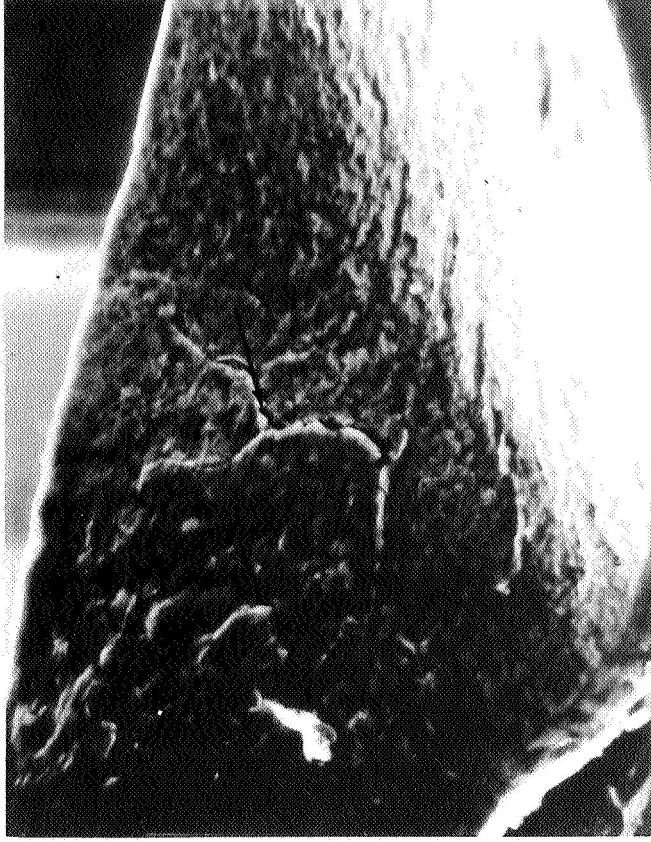
Figure 4. NA5-27473T (2N2222A), T.C. Wedge Bond, Die Side Bond, Microcracks at the Heel Before Power Cycling

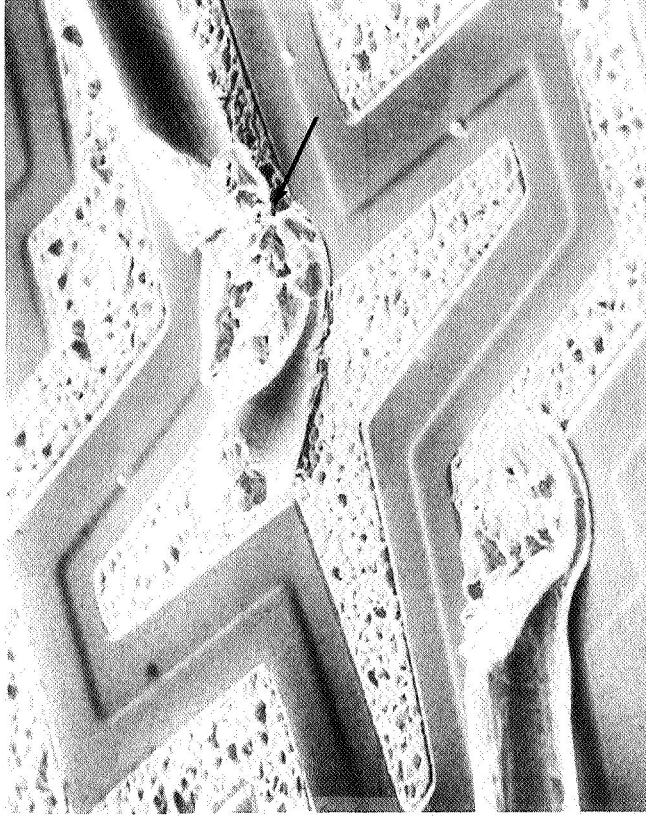
Figure 6. NA 5-27473 (2N2222A), T. C. Wedge Bond.
Emitter Bond Failed After 4632 Power Cycles

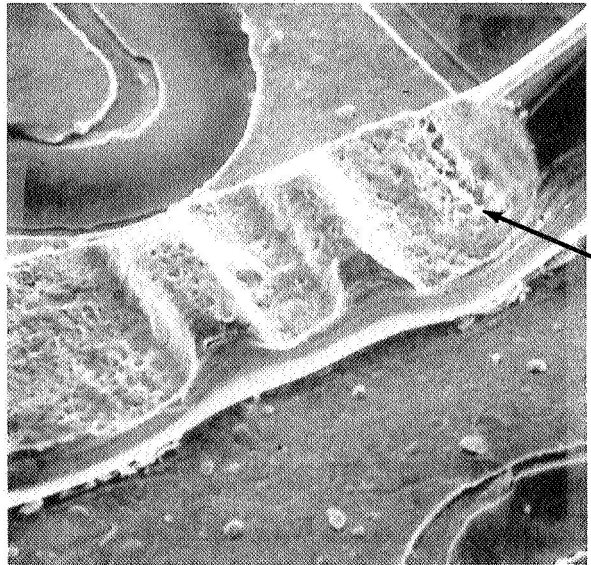
Device, serial number 76, exhibited the same failure mode and mechanism as device serial number 75. Cracks in the heel of the bonds were found also, before the power cycling test. Figures 16 through 18 depict clearly the increasing depth of the microcracks as a function of the power cycling.

Figure 16. Manufacturer "B" 2N2222A, Serial Number 76, Emitter Die Side Bond, Ultrasonic. Evidence of Microcracks at the Heel Before Power Cycling
